UNDERWATER BRIDGE INSPECTION REPORT

STRUCTURE NO. 5947

MISSISSIPPI RIVER

DISTRICT 3 - BENTON COUNTY

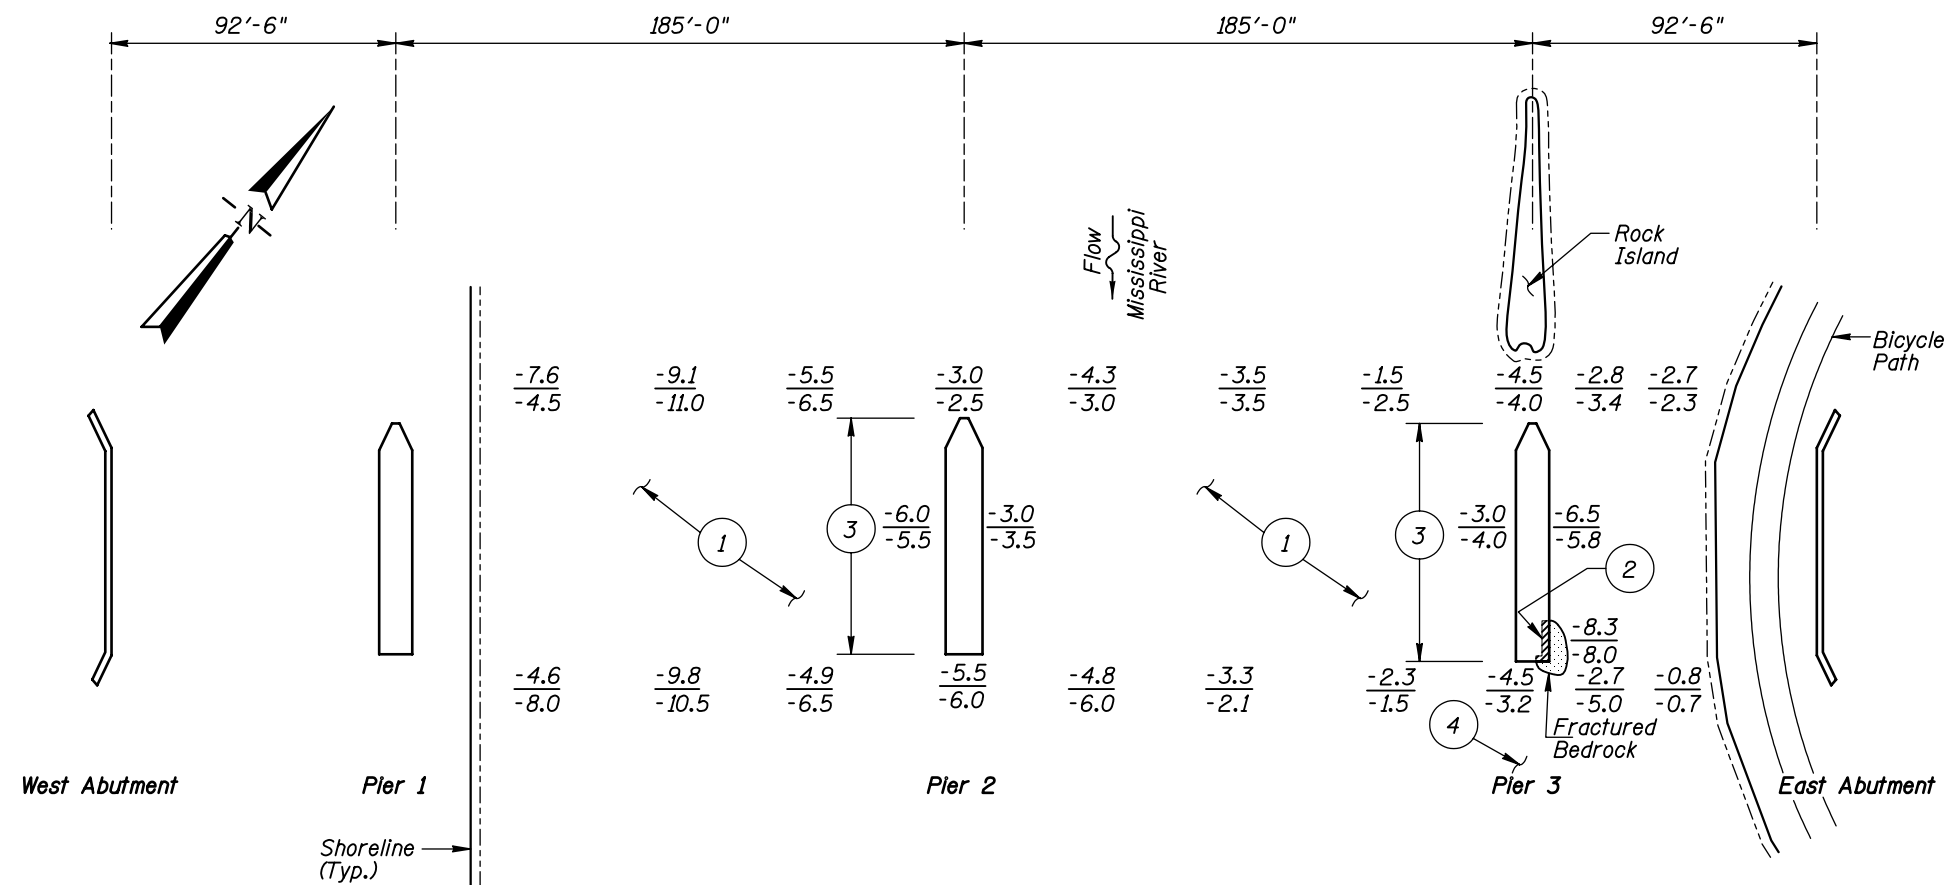
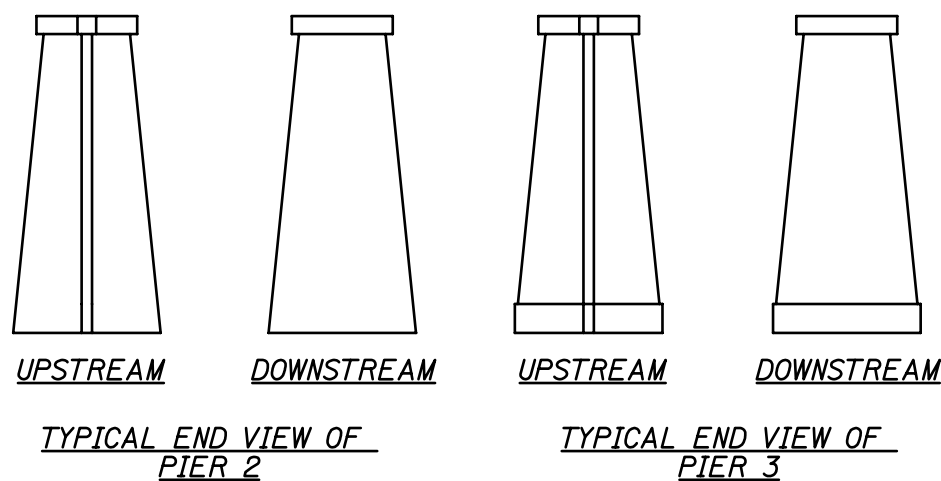
INSPECTION AND SOUNDING PLAN

- The channel bottom material consisted of large rocks and bedrock with no probe rod penetration.
- Undermining was observed at the southeast corner of Pier 3 due to an area of fractured bedrock. The undermining cavity was 1.3 feet high by 6 feet long with 2.5 feet of maximum horizontal penetration.
- The masonry construction of the substructure units were observed to be in overall good condition.
- 1- to 5-foot-diameter rocks scattered in the channel downstream of Pier 3.

- (A) Repair the undermining at the southeast corner of Pier 3 by placing grout bags and/or pumped grout within the undermined area to restore the full bearing capacity of the pier.

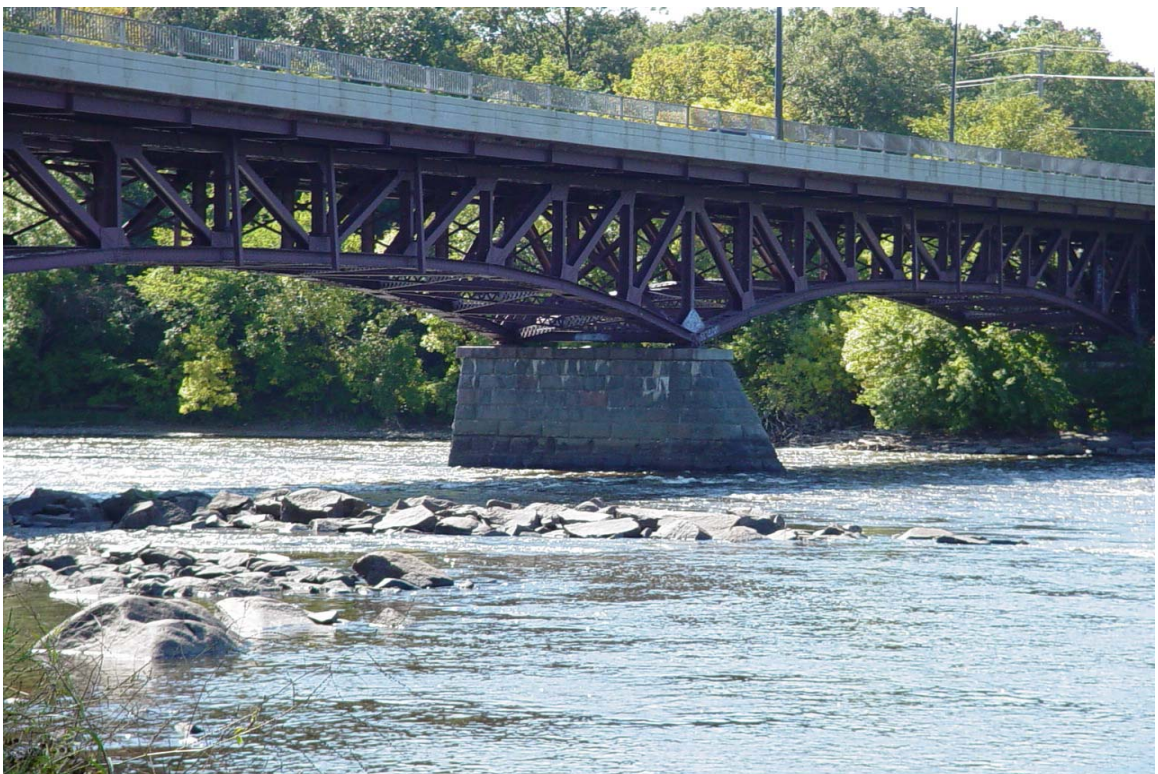
Photograph 2. View of Pier 2, Looking South.

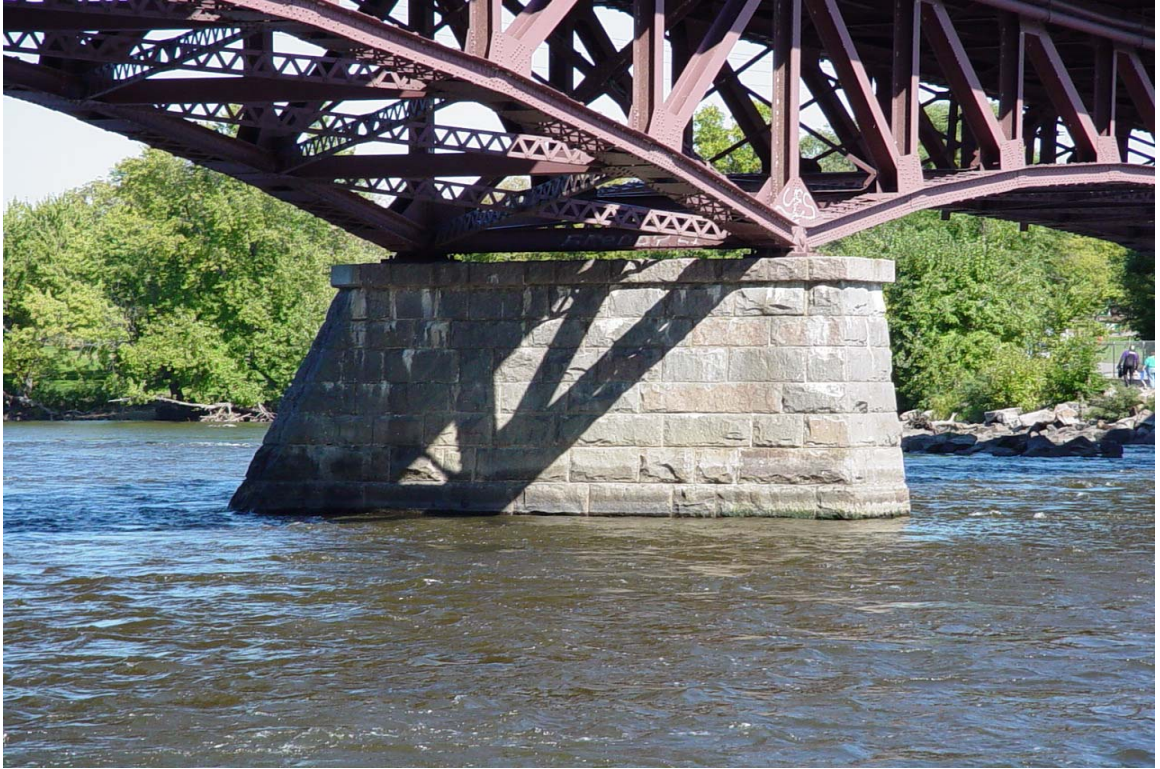
Photograph 3. View of Pier 2, Looking North.

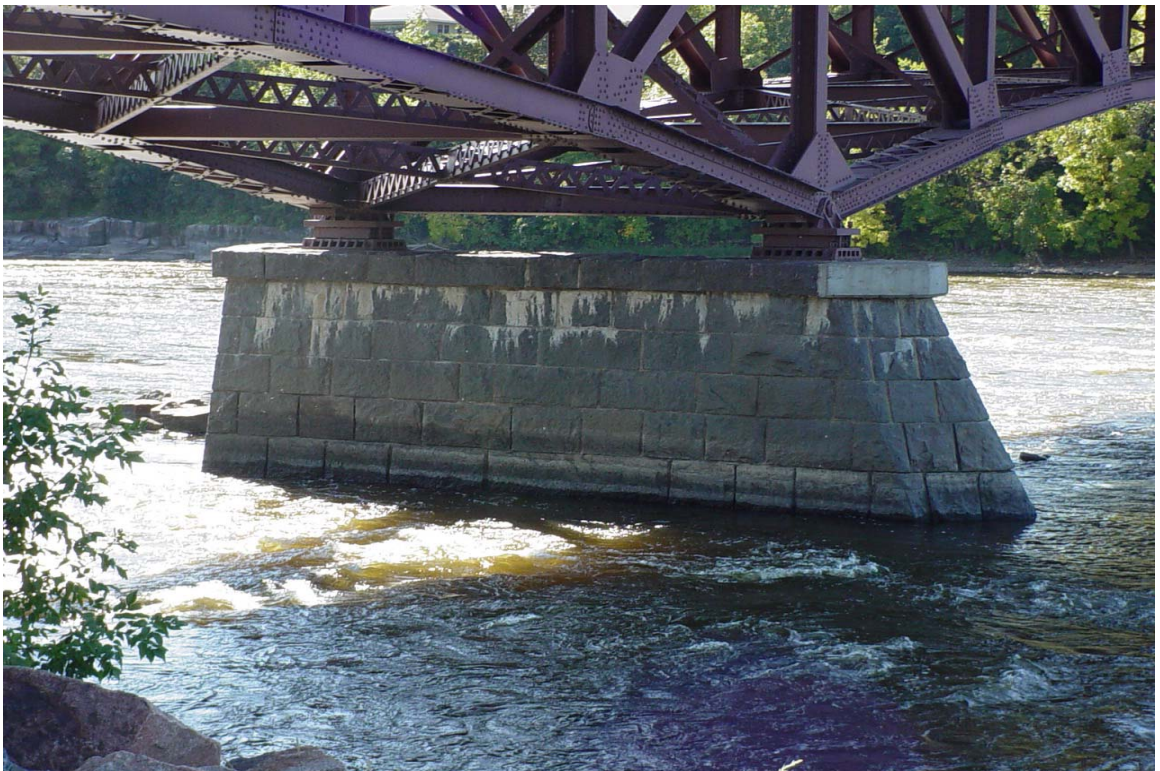
- (A) A 6-foot-long area of undermining was observed at the southeast corner of Pier 3 with a height of 1.3 feet and with 2.5 feet of maximum horizontal penetration. The undermining was due to the fractured bedrock channel bottom, which has shifted from under the footing.
- (B) The masonry of Piers 2 and 3 was in good condition with no defects of structure significance observed.

Photograph 4. View of Pier 3, Looking South.
